EXCAVATION SAFETY & UTILITY AVOIDANCE

2024 NGA Gas Operations School And Exhibit

TRAINING SESSION OBJECTIVES

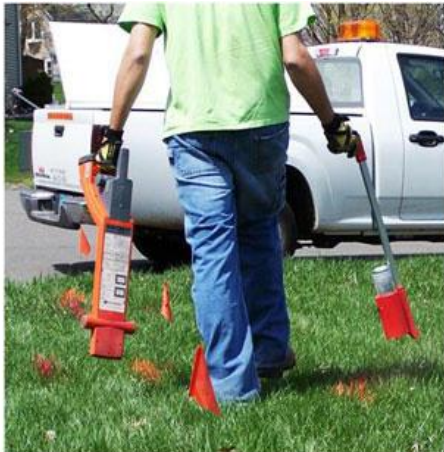
RED	ELECTRIC
YELLOW	GAS, OIL, STEAM
ORANGE	COMMUNICATIONS
BLUE	POTABLE WATER
PURPLE	RECLAIMED WATER
GREEN	SEWER / DRAINAGE
PINK	SURVEY MARKS
WHITE	PROPOSED EXCAVATION

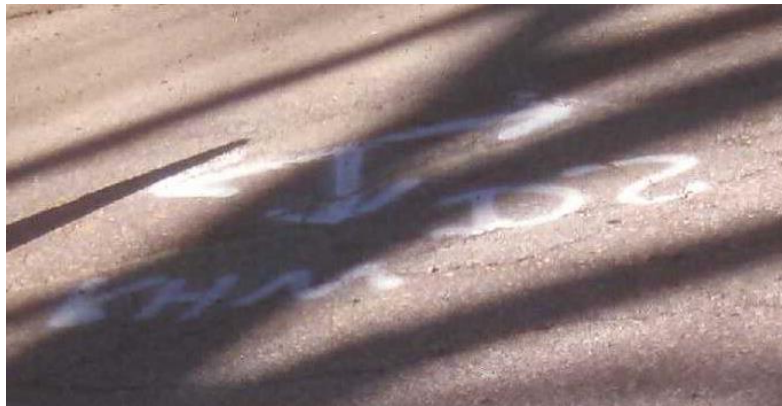
Request Number: 20152004489 Date: 05/12/2015 Time: 06:15		
Latitude: Longitude:		
State: MASSACHUSETTS Municipality: WORCESTER		
Address / Intersection: CATALPA ST		
Nearest Cross Street 1: BISHOP AVE Nearest Cross Street 2:		
Additional Information: ON CATALPA ST FROM THE INTER OF BISHOP AVE TO THE INTER OF MONTAQUE-PLEASE		
MAKE ALL INTER APPROX 35 FT		
Nature Of Work: GAS MAIN RELAY & SERVICE		
Area Of Work: WORKING STREET & STREET TO HOUSES		
Area Is Premarked: YES Start Date: 06/01/2015 Start Time: 07:30		
Caller: PATTY ZELESKY Title: GAS OPS CLERK Return Call: VM		
Phone#: 508-368-6711 Fax#: 508-368-6725 Alt. Phone#:		
Email Address:		
Contractor: NSTAR GAS		
Address: 25 QUINSIGAMOND AV City: WORCESTER State: MA Zip: 01608		
Excavator Doing Work: EVERSOURCE/RH WHITE		
Member Utility List		
Code	Abbreviation	Name

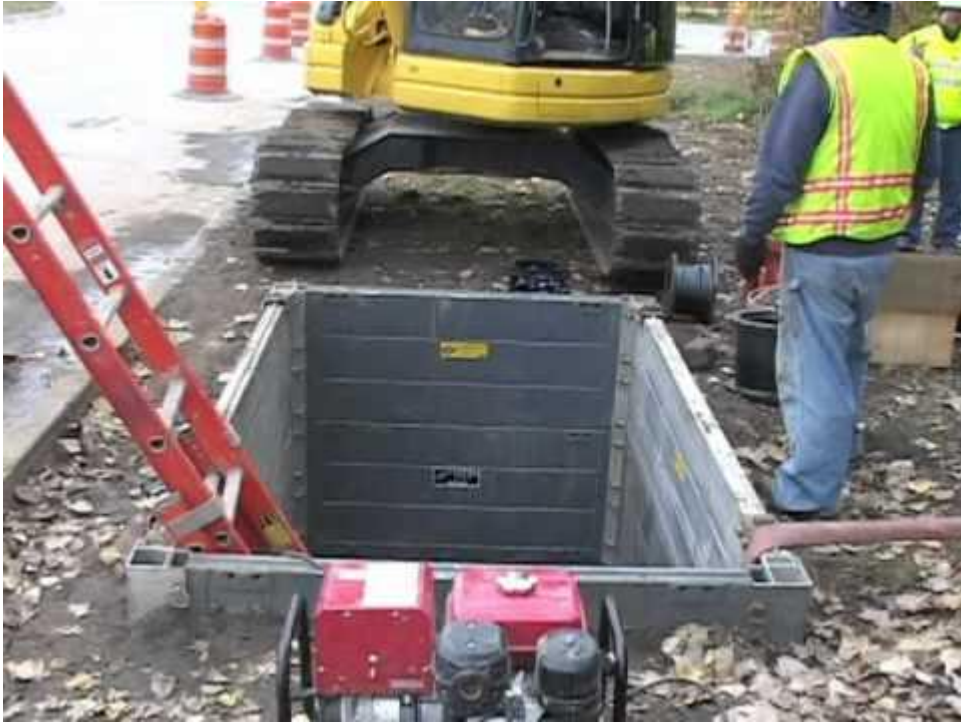
MINIMUM EXCAVATION REQUIREMENTS

- All spoils and tools must be kept 2' from the edge of the excavation
- Shoring box must extend 18" above grade, if materials/tools cannot be prevented from falling in
- All accumulated or accumulating water in an excavation must be controlled
 - If water cannot be controlled protection from a cave-in must be implemented
- All excavations that exceed 4'6" (5' per OSHA) must have an adequate protective system in place before employees may enter (Shielding, Sloping, Shoring)
 - Benching is not allowed at RHW as a means of protection, as all soils are classified Type C
- Excavations that exceed 20' in depth must have a protective system designed by a registered professional engineer

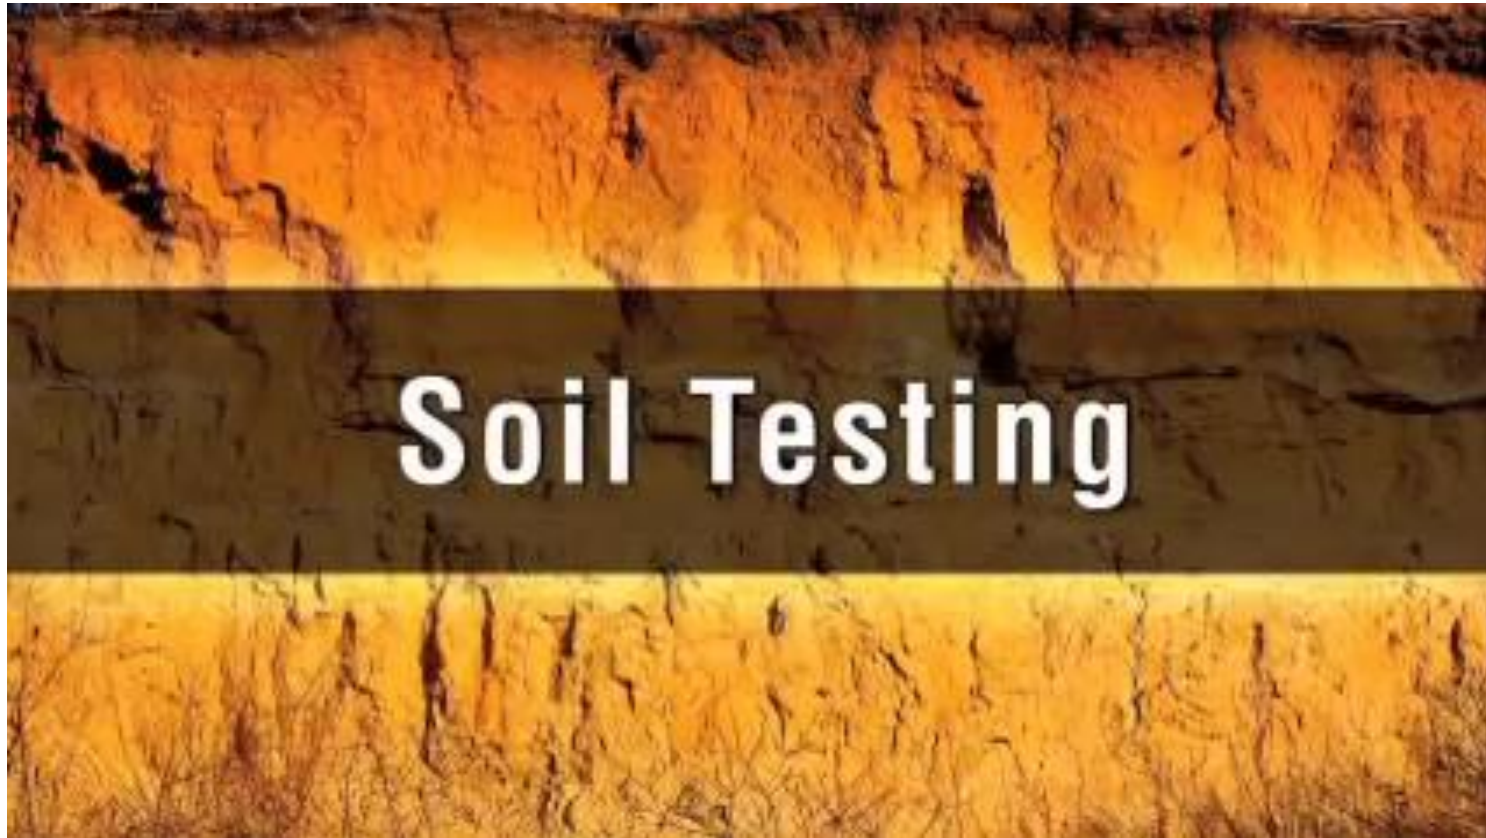
EXCAVATION PROTECTIVE SYSTEMS – SHIELDING – “TRENCH BOXES”

- Shield systems shall not be subjected to loads exceeding those which the system was designed to withstand – Tabulated Data
- Shields shall be installed in a manner to restrict lateral or other hazardous movement of the shield in the event of the application of sudden lateral loads – “Glove Fit”

- Employees shall be protected from the hazard of cave-ins when entering or exiting the areas protected by shields – Enter the shield via a ladder
- Employees shall not be allowed in shields when shields are being installed, altered, removed, or moved vertically

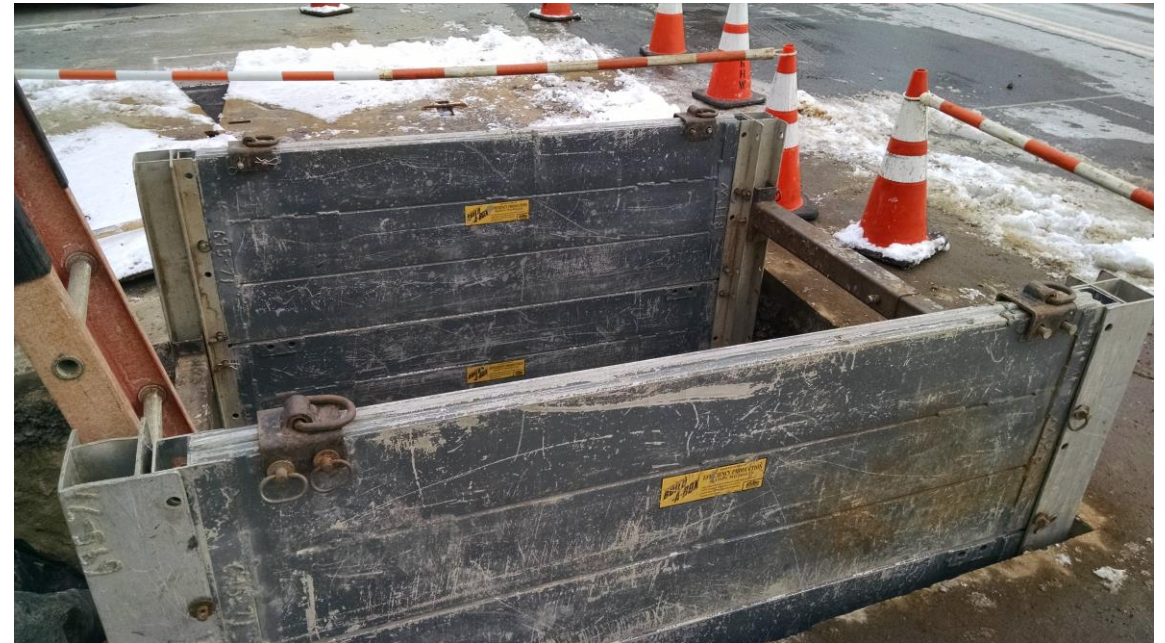
EXCAVATION PROTECTIVE SYSTEMS – SHIELDING – “TRENCH BOXES”

Model # of shield

MODEL		SERIAL NUMBER			
REFERENCE TO OCCUPATIONAL SAFETY AND HEALTH ADMINISTRATION RULES AND REGULATIONS, VOL. 54, NO. 209, 1031-69, PART 1926, SUBPART P					
SHIELD SIZE		PSF RATING	MAXIMUM ALLOWABLE DEPTH OF CUT (FEET)		
HEIGHT (FEET)	LENGTH (FEET)		SOIL TYPE TO BE EXCAVATED		
		MAXIMUM LATERAL EARTH PRESSURE CAPACITY AT TRENCH BOTTOM IN POUNDS PER SQUARE FOOT	TYPE A	TYPE B	TYPE C
			Stiff, cohesive soil. 25 PSF per foot of depth.	Medium cohesive to granular soil. 45 PSF per foot of depth.	Soft cohesive submerged sand. 60 PSF per foot of depth.
8'	16'	1167	47'	26'	19'
LIMITATIONS IN USE OF TABLE			DESCRIPTION	DESCRIPTION	DESCRIPTION
<ol style="list-style-type: none"> TRENCH SHIELD TO BE ASSEMBLED AND INSTALLED AS SHOWN AND IN ACCORDANCE WITH MANUFACTURER'S INSTRUCTIONS. BANK ABOVE TOP OF SHIELD TO BE LAID BACK ACCORDING TO OSHA REGULATIONS. CONSULT MANUFACTURER WHEN BOTTOM OF SHIELD IS NOT AT TRENCH BOTTOM. ADDITIONAL SHIELDS MAY BE STACKED WITH NO PENALTY IN DEPTH OF CUT. DEPTHS OF CUTS SHOWN ARE BASED ON EXAMPLES OF VARIOUS SOIL CONDITIONS. VERIFY ACTUAL SOIL PRESSURES PRIOR TO EACH USE. ANY MODIFICATIONS OR ALTERATIONS NOT ALLOWED UNLESS APPROVED IN WRITING BY EFFICIENCY PRODUCTION, INC. DEPTH CERTIFICATION IS BASED ON SHORT TERM EXPOSURE WITH EXCAVATION OPEN A PERIOD OF TIME EQUAL TO 24 HOURS OR LESS. CONSULT THE MANUFACTURER SHOULD LONG TERM EXPOSURE BE REQUIRED. 			Clay, silty clay, sandy clay, clay loam, unconfined compressive strength of 1.5 tons per square foot or greater. (See Note 9 on reverse side).	Clay with unconfined compressive strength greater than .5 TSP but less than 1.5 TSP, cohesionless gravel, silt, silt loam or sandy loam. (See Note 9 on reverse side).	Clay with unconfined compressive strength less than .5 TSP, submerged sand, fractured rock that is in place. (See Note 10 on reverse side).

Serial # of shield

Soil type

Max. depth

Soil description

Limitations

Must be certified by RPE

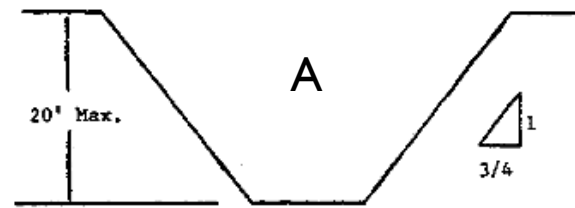
SIMPLE SLOPE -- GENERAL

EXCAVATION PROTECTIVE SYSTEMS – SLOPING AND BENCHING

- Minimum slopes must be met for each type of soil
- Type C soil **CANNOT** be benched

Soil type	Height/Depth ratio	Slope angle
Stable Rock	Vertical	90°
Type A	3/4:1	53°
Type B	1:1	45°
Type C	1 1/2:1	34°

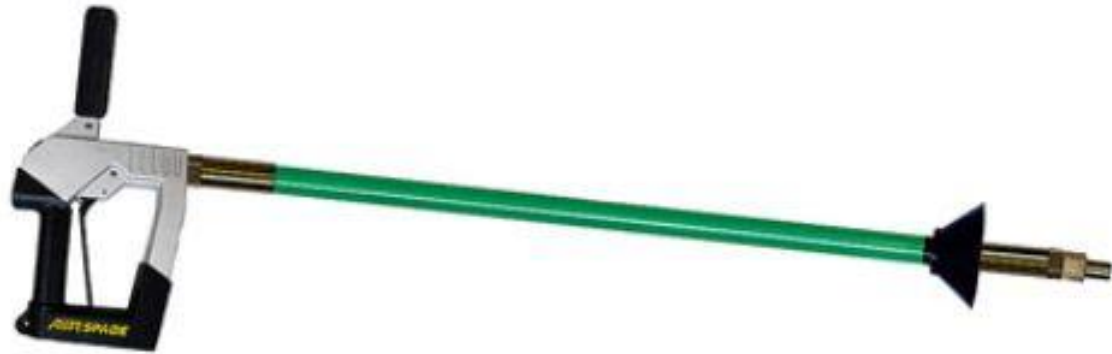
Utility Air Spade 4000

- Harnesses the power of compressed air to safely uncover underground utility lines without harm.
- High-performance, patented supersonic nozzle generates a laser-like jet that moves at twice the speed of sound for faster, more effective digging.
- Non-sparking nickel aluminum bronze blend nozzle, brass components, electrically insulated 4' barrel rated to 300kV
- Lightweight, ergonomic handle, maximizes jobsite safety while minimizing operator fatigue. Dead-man trigger ensures safe operation and trigger guard prevents accidental activation.
