# Utility Technology Update

June 5<sup>th</sup>, 2020 NGA Gas Ops Instructor Session

# Robotic Internal Cast Iron Joint Remediation CISBOT OVERVIEW

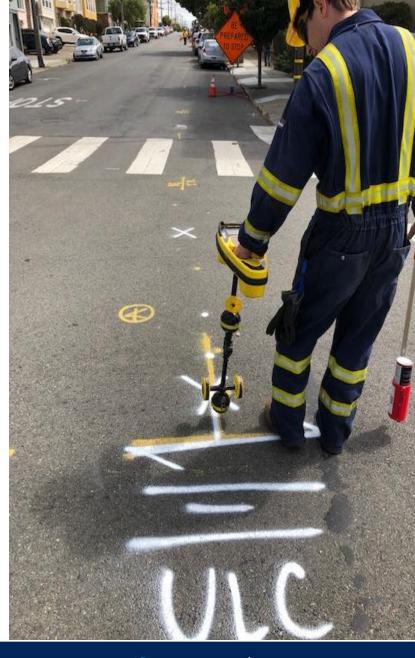
## Locating PE Fittings and Fusions

- Identify and locate PE fusions and taps from inside the main, then mark above ground.
- In-Pipe Locating was used to locate and mark out above ground the location of two butt fusions in order to be able to conduct an analysis.

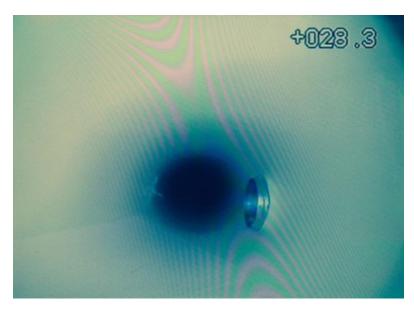
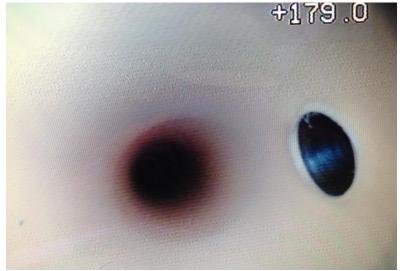
## Verify Proper PE Installations

Any features visible within the pipe can be verified, located and marked out on the street surface

- In-Pipe Locating used to verify installation of tapping tees due to suspected installation issues
  - Client needed to validate proper fitting installations and precisely locate fittings from above ground
  - Inspected 286 tees through 38 excavations; 20,000' of PE main
  - 35% of tee installation failed the test and were able to be efficiently remediated.
  - Overall project resulted in a 50% reduction in excavation

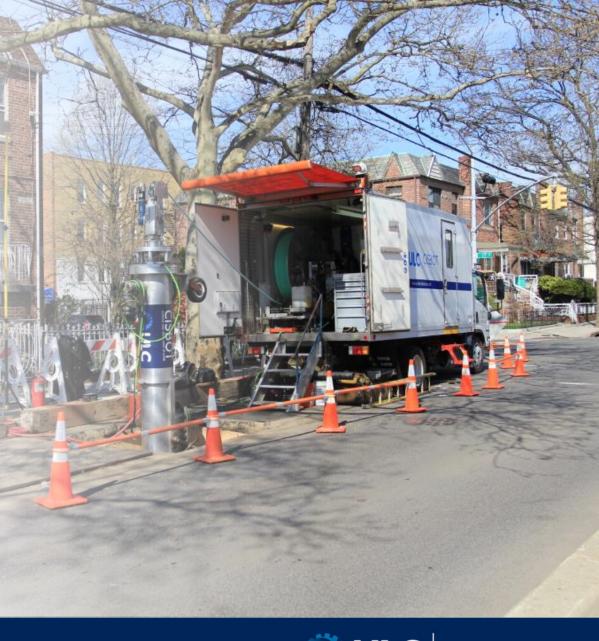
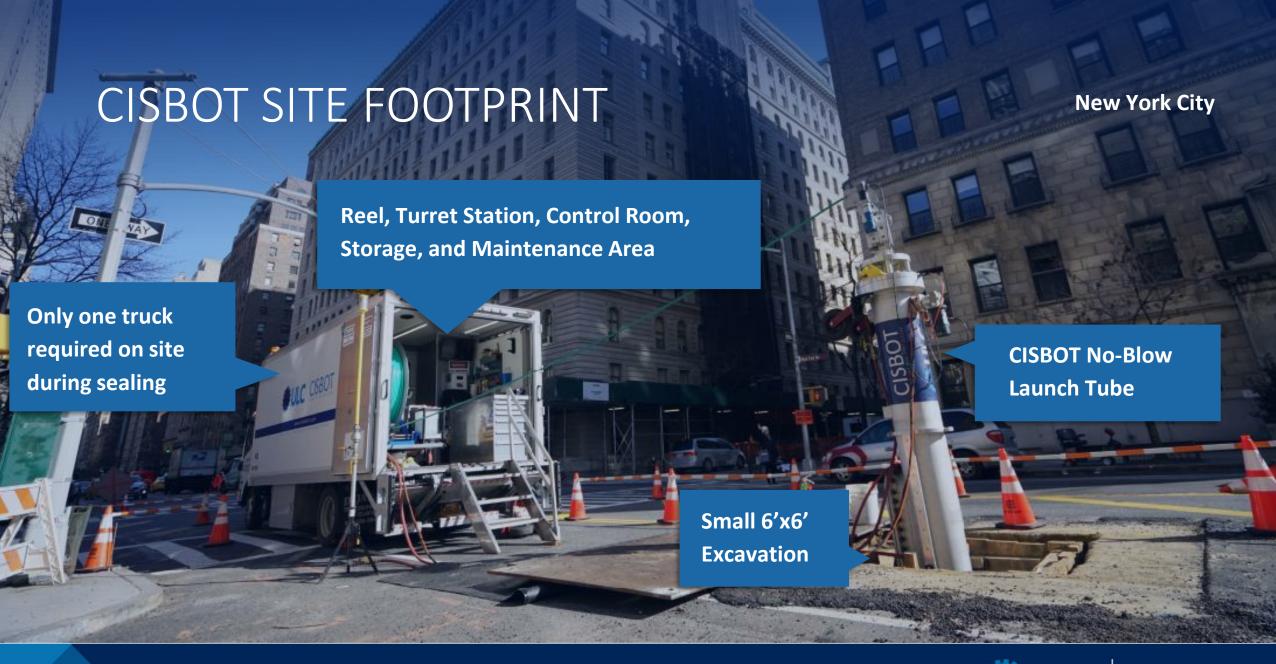
## **CISBOT**

CISBOT enters the main through a very small opening in the street and travels hundreds of feet in either direction to remediate the joints using a computer controlled anaerobic injection method.

- Remediate up to 110 joints (1500ft) using a process proven to extend the life of the pipe by 50 years
- Gas stays on the entire time
- ULC has 13 robots working every day in the US and UK
- More than 25,000 cast iron joints sealed since 2010
- Considered a capital expense by utilities and part of approved rate cases

- No blow launch into live gas mains up to 25 psi
- Launches through industry standard valves & fittings
- Articulating body allows vertical entry

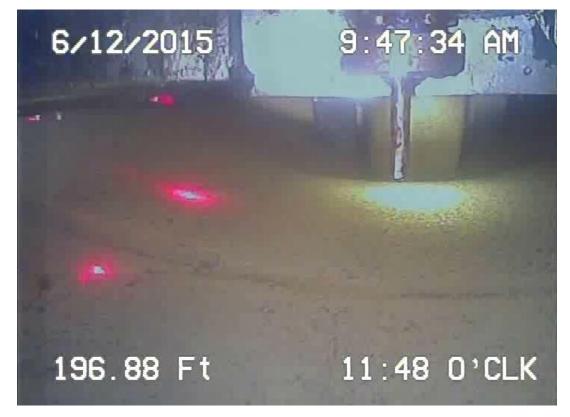
CISBOT combines an advanced drilling and injection process with sensor feedback and remote monitoring to remediate joints:

- Lasers assist the robot operator in identifying the joint gap and positioning the robot at the ideal location in the main
- CISBOT drills a small access port through the spigot
- Operator has control over drill speed and thrust

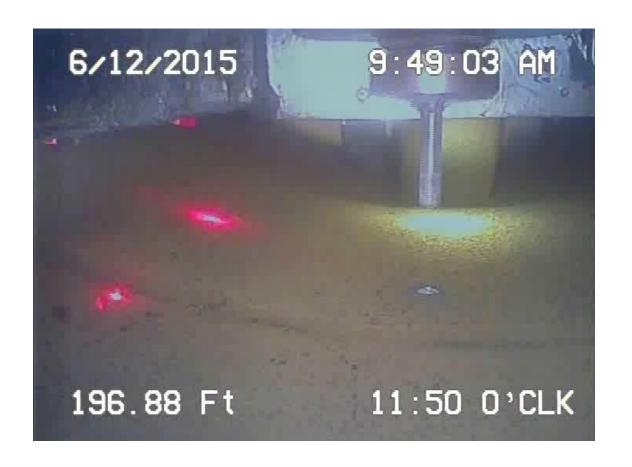
CISBOT combines an advanced drilling and injection process with sensor feedback and remote monitoring to remediate joints:

- A specialized nozzle injects an industry trusted sealant directly into the joint packing material through the access port
- Sensor feedback allows the robot operator to monitor the pump pressure and flow rate of the sealant until the prescribed volume of sealant is delivered into the packing material
- Six cameras on the CISBOT robot enable our robot operator to monitor the injection process and 'wicking'
